GASEOUS EROSION AND CORROSION OF TURBINES

Bartosz Olzak, Janusz Szymczak, Andrzej Szczepankowski

Abstract

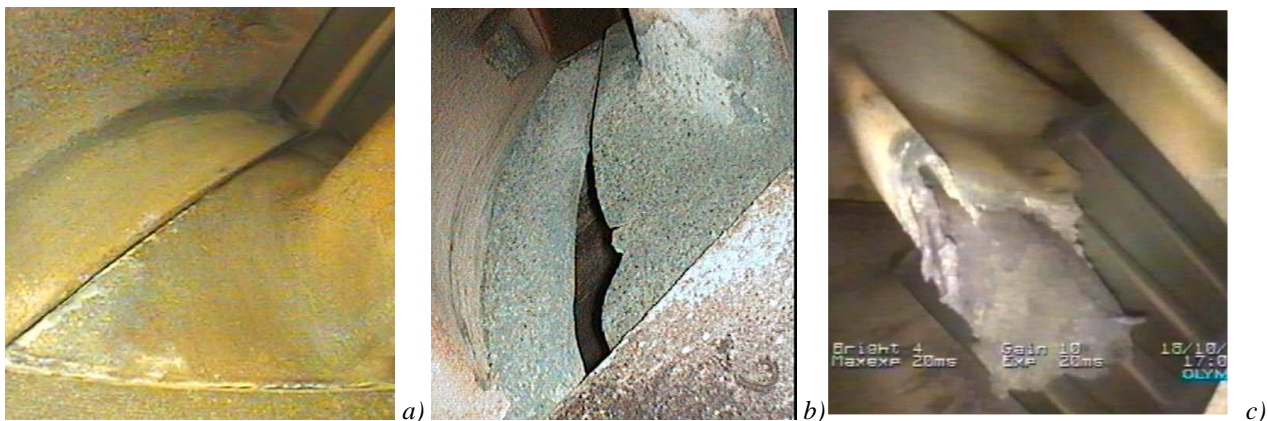
Fig. 1. The part of jet engine HP turbine stator vane [7]

The source of this was badly organized combustion which caused local, short duration combustion area (flame) downwind shift (up to turbine blades). It caused a situation in which during start-up procedure fuel-air mixture combustion could occur at turbine stator vane area and increase temperature there rapidly.

This process periodic disturbances are illustrated by noticed changes of surface state. It should be mentioned that combustion chamber section structure corresponds with these disturbances. That's because the axes of injectors are directed to turbine inlet stator vane hub. It occurred by burning insulation coating and then by developing blade material loss (fig. 1c). The stator blades internal cooling didn't slow this process down.

Gaseous corrosion. a) ÷ c) corrosion and erosion material „washing out” form two of stator blades hub

Moreover, the signs of gaseous corrosion show that the whole process is a long lasting one and started when the engine got into service (fig 1b). It was accelerated by existence of some parts of W, Mo, Co and some sulfur compounds in the fuel. Corresponding to military norm for JET A-1 (or F-35) fuel the sulfur compounds fraction is up to 0.3 % by volume. It can cause that carbon-dioxide fraction in combustion products (exhaust emission) can get about 0.014% by volume [3]. So, the higher sulfur fraction in the fuel the higher SO₂ and SO₃ fraction in the exhaust emission – the threat of turbine damage increases.

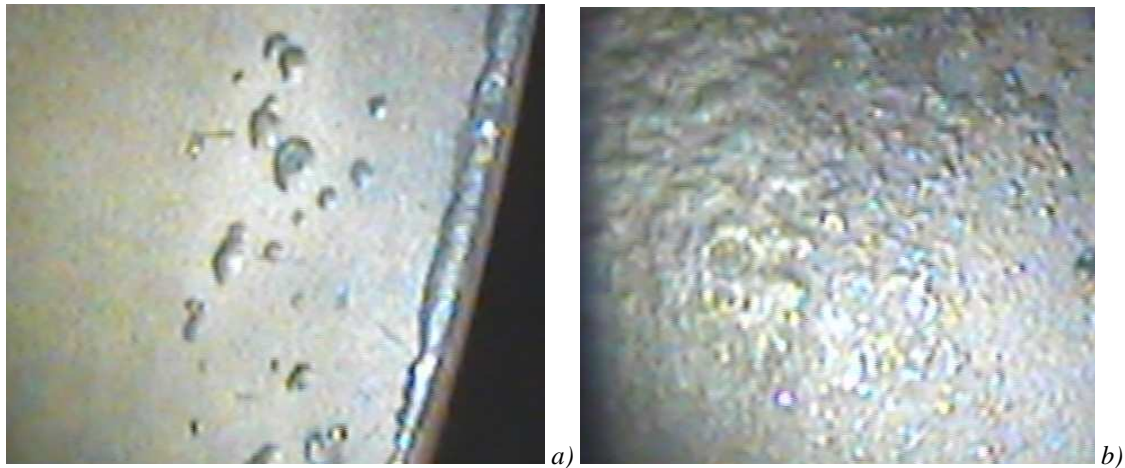
*Fig. 2. The view of pressure side of turbine rotor blade of a jet engine used in high salinity environment [7]
Two following stages of a) ÷ b) oxidation and sulphidation.*

The lack of coating surfaces making precision during production and especially overhaul can cause a case illustrated in Fig. 2. It is certified by their placement (blade pressure side and leading edge LE). Also working environment that is a high salinity one (low level flights over sea) had an influence on this. On the upper example [4] we can observe early stage of oxidation (fig. 2a) characterized by small area of changes and increasing oxidants bubbles (low roughness change). In fig. 2b we see developing phenomena of oxidants bubble rise and their area development (high roughness changes). The chromium depletion from lower alloy surfaces had started.

One of delay methods of his process is engine clearing but its frequency should be determined during endoscopic testing.

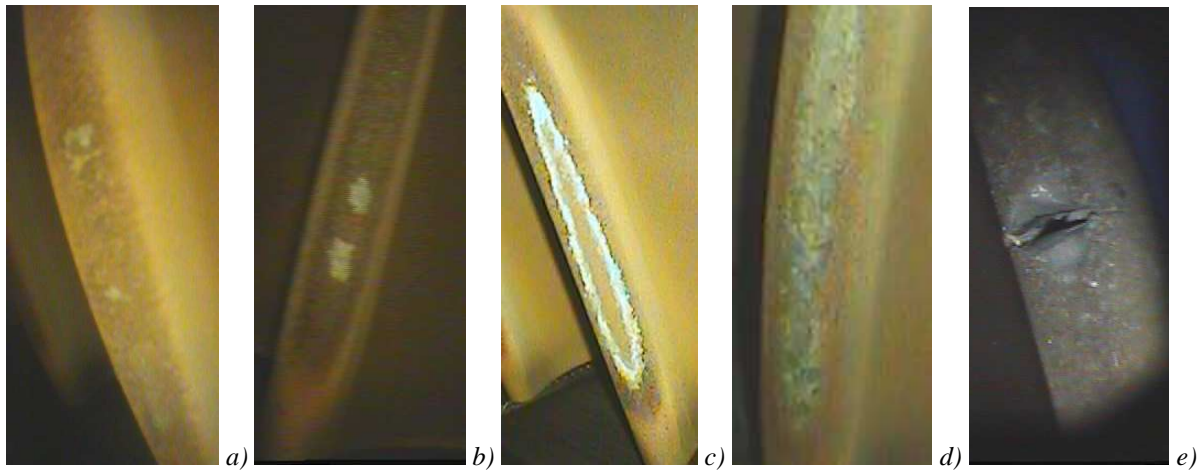
Fig. 4. A view from LE of HP turbine rotor blade of jet engine [7]. Following stages a) ÷ e) of damage

In figure 4 (a ÷ b) coating damage on blades LE – its area increases (by the blades hight) together with turbomachinery service time (fig. 4b). The lack of not only coating but also insulating layer can be observed after another 25 service hours (fig. 4c). We know that summarized service time for this engine is not higher than 80 hours. Described damage was observed for 80% of blades in this turbine rotor vane. It could be caused by turbine cooling system malfunction.

The mentioned engine is still in service because our experience shows that before destruction we will first see cracks in pure alloy of a blade (fig. 4e) – this is dangerous for fighter jet service.
