## TYPES OF DAMAGES TO TURBINES OF AIRCRAFT TURBINE ENGINES; DIAGNOSING CAPABILITIES

Artur Kulaszka, Marek Chalimoniuk, Józef Blachnio

*Air Force Institute of Technology*  
ul. Księcia Bolesława 6, 01-494 Warszawa 46, Polska  
tel.: +48 22 6852282, e-mail: artur.kulaszka@itwl.pl

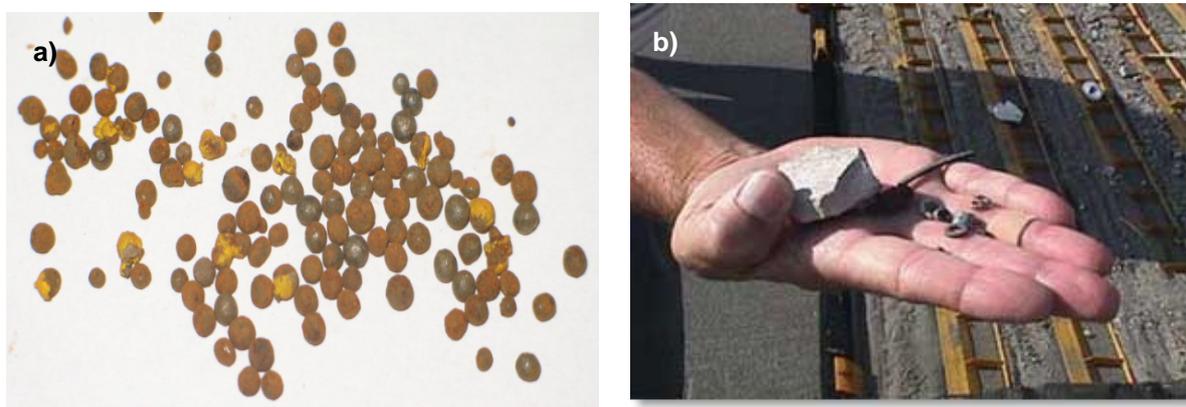
Fig. 2. Examples of impurities found on a runway: a) steel balls –paint-removing residues [3], b) fragments of concrete, washers, cotter pins [6]

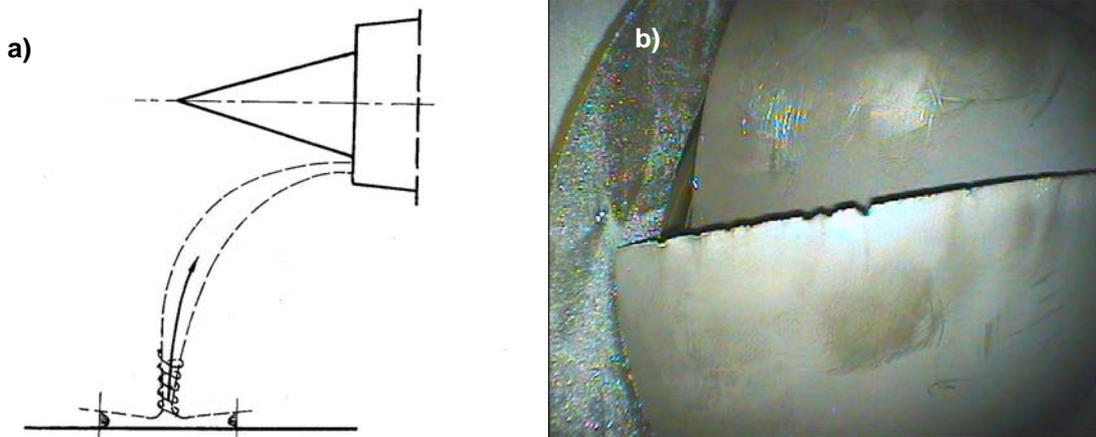
Fig. 3. Schematic diagram of air vortex at engine intake - a) [7], damage to compressor blades caused by impurities ingested by air vortex from the runway – b) [3]

Impurities ingested by air vortex cause mechanical damages to individual components of gas path – in particular, to compressor rotor blades (Fig. 3). The result of such damages is disturbance of engine performance parameters, what has also adverse influence on working temperature of the gas turbine. On account of the complicated nature of thermal and mechanical loads on turbine blades inadmissible are any mechanical and thermal damages to blades, because it may lead to the break-off of a blade, and consequently to the engine damage, and hence, hazard to flight safety. Some types of mechanical damages resulting from the foreign-matter ingestion are detected after finding damages to the compressor’s first-stage components during pre- or after-flight maintenance, or in the course of the first borescope examination after the event, carried out during periodical maintenance of the engine (Fig. 4).

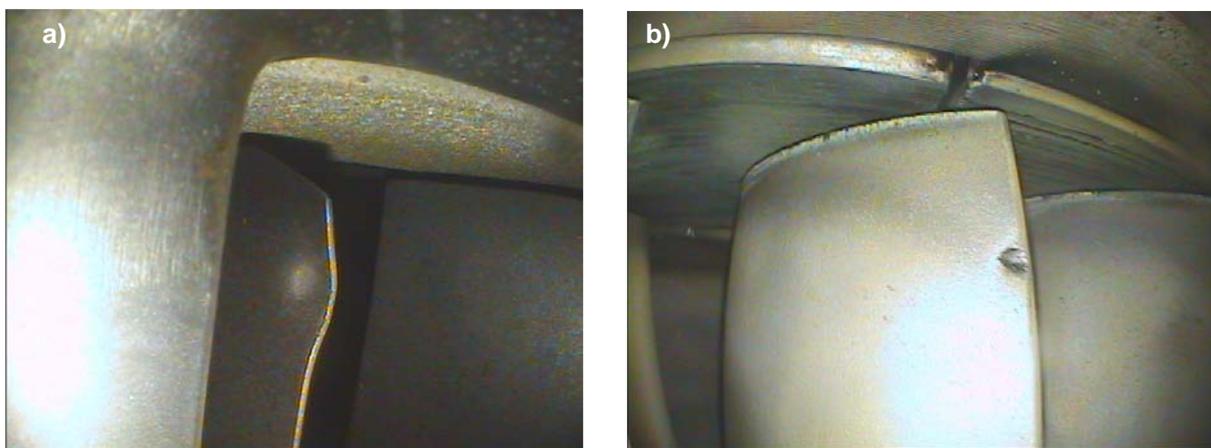
Fig. 4. Examples of damages to: a) compressor blades, b) turbine blades, effected by the ingestion of steel balls from the runway pavement [3]

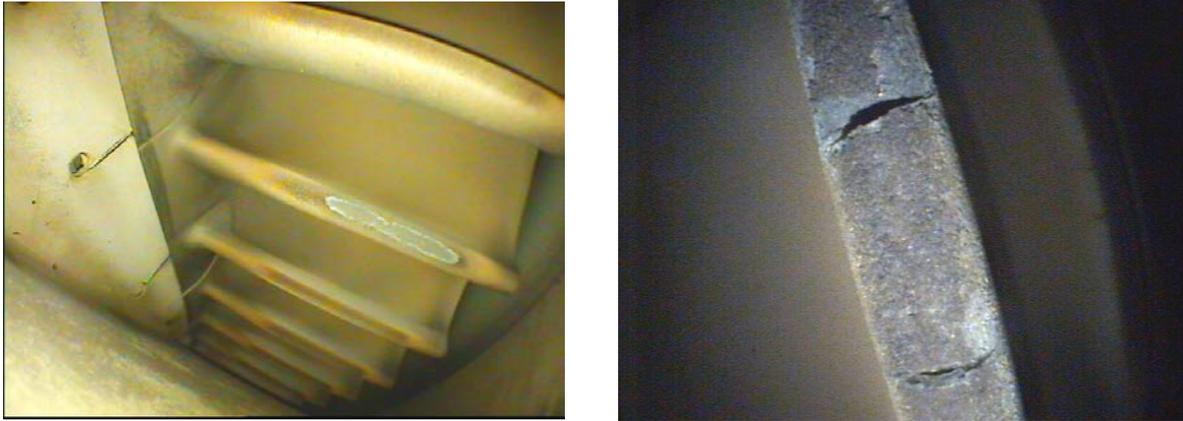
Small spot damages or small abrasions of blade surface are often invisible during first hours of engine operation after the damage has occurred, and they are not detected by a diagnostician in the course of diagnostic examination. A damage to blade protective coating together with high temperature and exhaust-gas induced aggressive environment may result in the overheating and burnout of the native material of the blade (Fig. 5).

*Fig. 5. Exemplary types of thermal damages to leading edges of turbine rotor blades [3]*

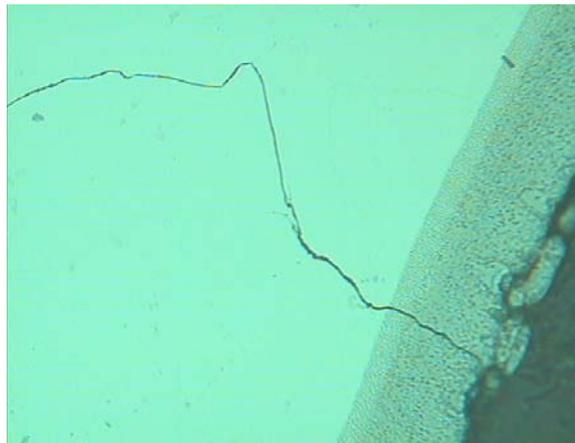
The break-off of a turbine rotor blade caused by spreading a new type of a protective coating applied with diffusion method onto the blade material is one of the most interesting and at the same time the most dangerous events. In the course of turbine operation a fragile coating suffered cracking; the crack propagated into the native material of the blade and finally resulted in the break-off of the blade (Fig. 6).

*Fig. 6. Protective-coating cracking; the crack keeps propagating into the blade's native material [3]; magn. x 450*

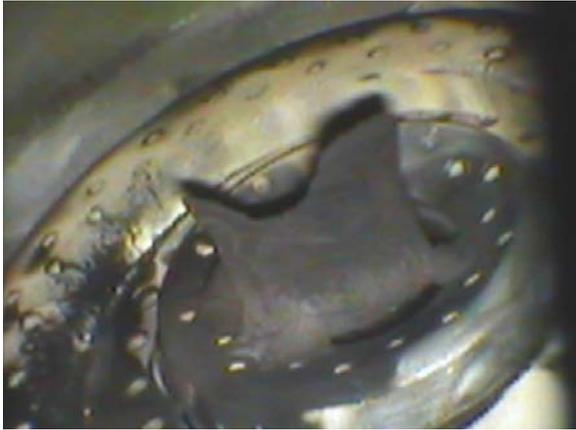
Incorrect fuel pressure, its physical and chemical properties deteriorated by various kinds of impurities, and misalignment of the flame tube injector prove conducive to the formation of carbon deposit on the injectors (Fig. 7) and other sub-assemblies, what results in faulty fuel spraying. This, in turn, results in disturbance of the combustion-process organisation, and consequently of temperature distribution and cooling of individual components of the hot section of the engine. What results is overheating of material of combustion chamber and turbine blades (Fig. 8).

*Fig. 7. Carbon deposit on fuel injector of a turbojet [3]*

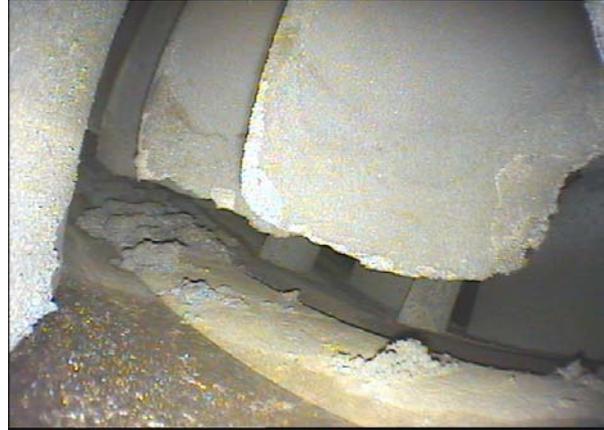
*Fig. 8. Thermal damage to turbine blades [3]*
