SOME ADJUSTMENT AND EXPLOITATION PROBLEMS OF THE CONTROLLABLE PITCH PROPELLER PNEUMATIC AND HYDRAULIC CONTROL SYSTEMS

Czesław Dymarski

*Gdansk University of Technology
Faculty of Ocean Engineering and Ship Technology
11/12 G. Narutowicza Str., 80-233 Gdańsk, POLAND*

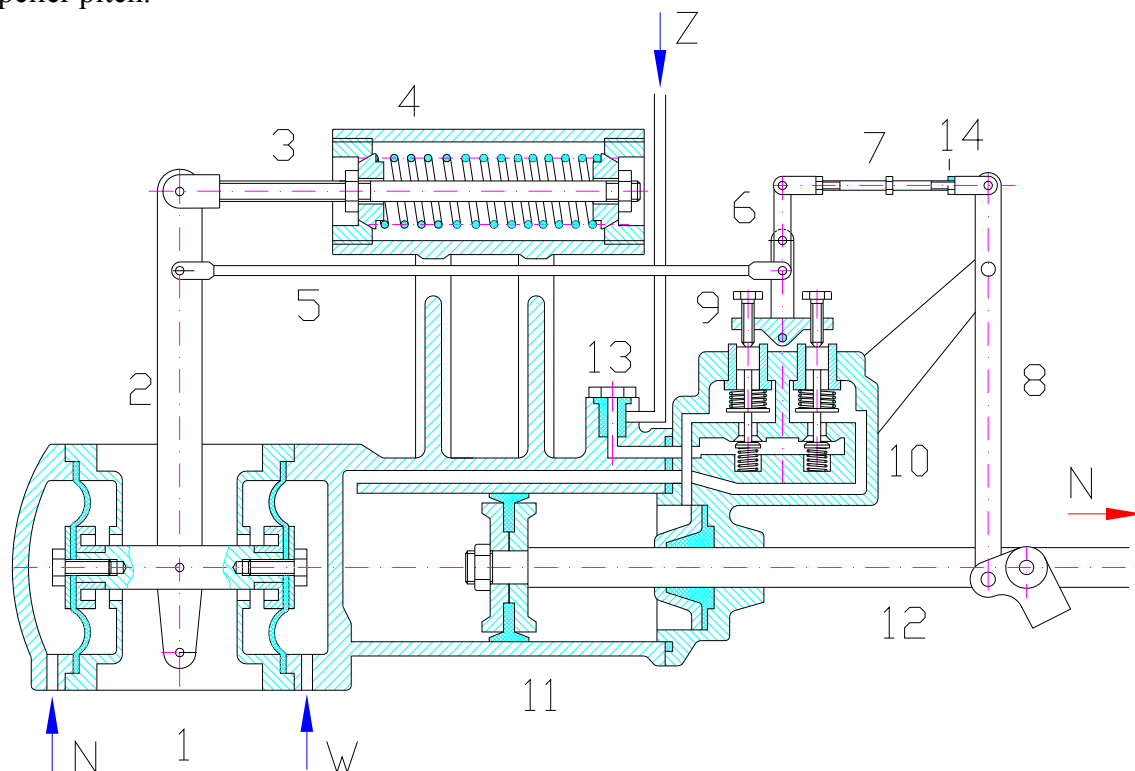
Fig. 4. A simplified drawing of the pneumatic servomotor of the controllable pitch propeller remote control system. Letter nomenclature: N – „ahead” direction, W – „astern” direction, Z – air supply.

Two hours after collision during the engine room machinery inspection the ship’s engineer spotted the broken connecting link (item 7 on fig. 4). A break intersection was at a fore face plain of a left lock-nut, which is shown on fig. 5. No other damages were found.

The remote pneumatic control system without broken connecting link was also tested. Even by very light finger pushing on the upper end of the lever 6 (on fig.4) the piston rod 12 moved in one or another direction according to direction of finger pushing. In full range of control it worked correctly. During this test I have noticed one characteristic feature of the pneumatic servomotor. It was that from each set position of the piston rod after stopping pushing on lever 6, it automatically moved to “full ahead” position.

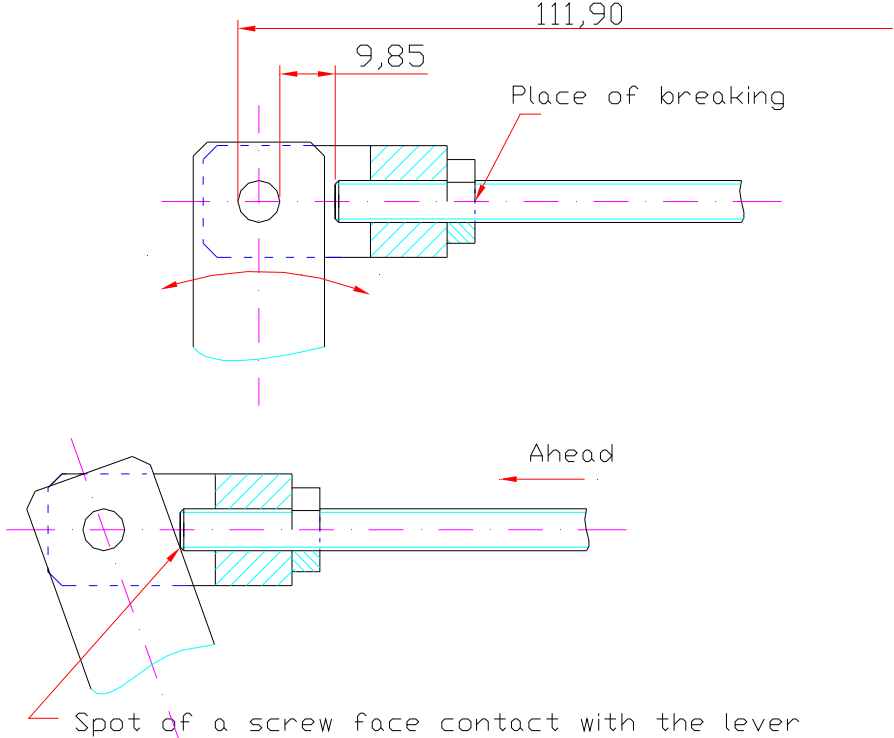
would be exactly the same as in the damaged one. Conformity of two most significant dimensions, namely a distance between outer surfaces of botch pins of connecting link and distance between the pin and face surface of the connecting link screw, which are shown on fig. 5, was checked in front of the commission.

The following tests were conducted with using the remote pneumatic control system and checking conformity of the set values with real values of the propeller pitch during a few full cycles of the pitch changing. Also this time the system worked correctly. In this situation I have decided to repeat last test changing gradually, step by step the propeller pitch and each time observing and touching the connecting link 7, gently pressing it by finger. In almost all steps the pressing connector displaced slightly crosswise in a clearance range, but just in positions “full ahead” and close to it the connector tensed and stiffened. Precise observation of this connection unit revealed a reason of this stiffness. Just in mentioned above position close to „full ahead”, a face surface of the connector link screw rested against the lever 6 in such way, as is shown on fig. 5. Because of it, a bending moment in the screw was generated. This additional bending moment load was undoubtedly many times bigger than a nominal axial force load.

Fig. 5. An articulated joint of the connecting link with the lever in “zero” and “full ahead” positions with shown two dimensions checked in front of the commission
