AN ANALYSIS OF CHOSEN ENGINE FAILURES OF THE “SEISMIC RESEARCH” TYPE SHIPS

Artur Bejger

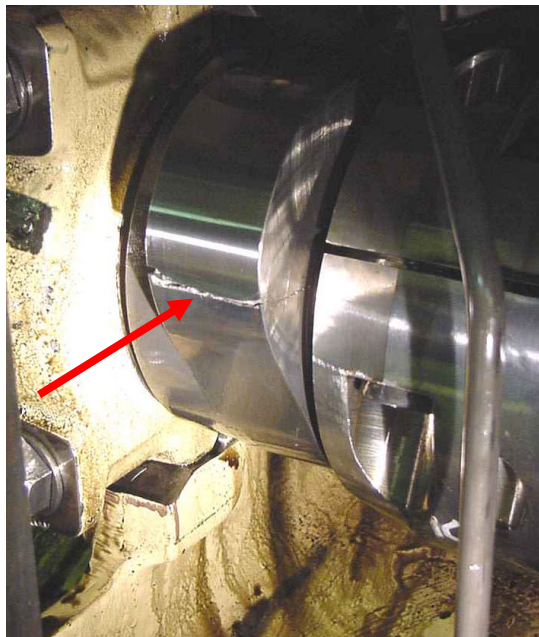
A cracked cam of the fuel pump was found on one of the cylinders. (Fig. 2) Thus, a decision was made to replace the faulty part of the camshaft. It was feasible thanks to a segment structure of the shaft, which consisted of four parts. The replacement of one of the four segment parts was performed without the help of a specialized service by dismounting the faulty part and mounting a new segment in the same place. Very similar failures occurred on a few sister ships, therefore, the manufacturer concluded that the failure was due to the inappropriately chosen material out of which the cam was made. This led to a change of record made in the preventive maintenance schedule referring to the frequency of the whole timing gear system surveys of all engines of this type.

Fig. 2. The crack on the cam of the fuel pump (marked with an arrow)

Despite replacing the cams with new ones, the main problem remained. Most probably it was not caused by faulty material but by the miscalculation of the interference size at cam mounting. When cams were being mounted on the shaft, the shrinkage method with an induction heater was applied (Fig.3). An inappropriate construction size of assembly clearance (negative allowance) caused that after the mounting, the stress was too high. Additional stresses on the cam at operation lead to exceeding the acceptable stresses and resulted in piling up the stress especially at the notch which in this case was the splineway.

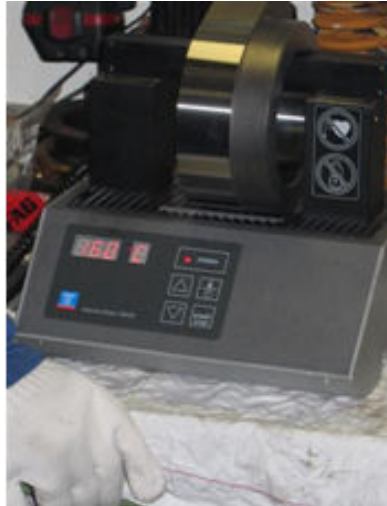
Fig. 3. Warming up of the shaft gear cam with the use of an induction heater

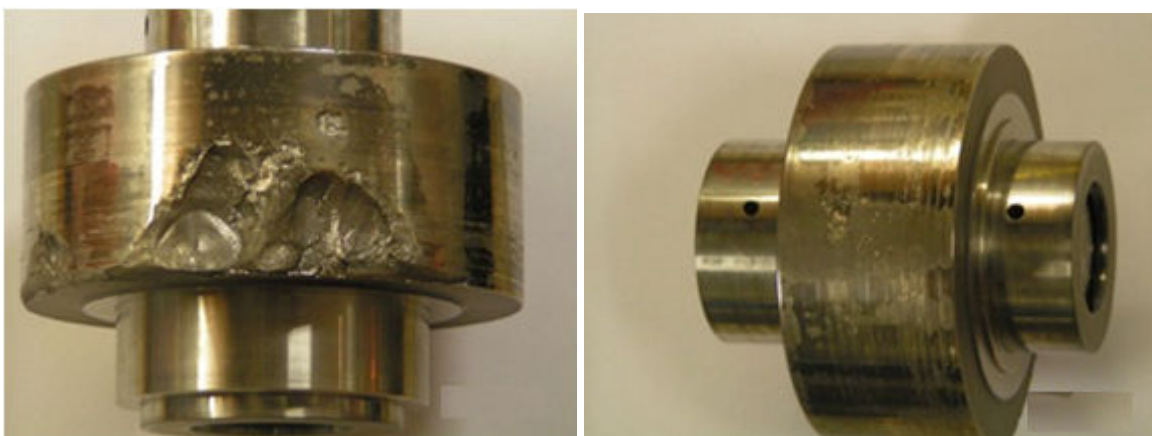
The increased frequency of surveys of the timing gear system resulted in finding another type of failure, i.e. a very pronounced wear of rollers (Fig.4) and cams of the injection pumps (Fig. 5). The service of Rolls-Royce, which is the manufacturer of Bergen-Diesel engines, did not pinpoint the cause of the roller and injection pump cam wear. It replaced them with new ones, which after a relatively short period of operation got identically worn as those before. The author of this study analysed the changes of the surfaces of the studied rollers and cams. The types of faults pointed to classical pitting which is fatigue wear caused by cyclic interaction of contact stress occurring at superficial layers of elements that are rolling or rolling with a slide. at lubricated contact within the Hertzian contact stress limits. Thus, it is the fatigue wear occurring in the presence of oil.

Fig 4. Damaged rollers of a fuel pump

In the first stage, the fatigue was due to the cyclic presence of stress. Initiation of cracks and the appearance of the first micro-crack is usually connected with the place of the highest material stress, i.e. the moveable Bielaiev point [3]. Apart from the possibility of crack initiation at the Bielaiev point, they can also appear on the surface of the material even when the ratio of the tangent force to the axial one is not equal to 1/3. Any surface fault or structure discontinuity may be the source initiating fatigue cracks. During the first stage, lubricating oil slows down the progress of fatigue processes, as it relieves unitary stress in the contact area, which has a beneficial influence on material surface durability. Thus, the effect of wear can only be seen after the system has operated for a period of time. Therefore, the fatigue wear in the presence of oil occurs much later than it is the case for the contact without lubrication [3].

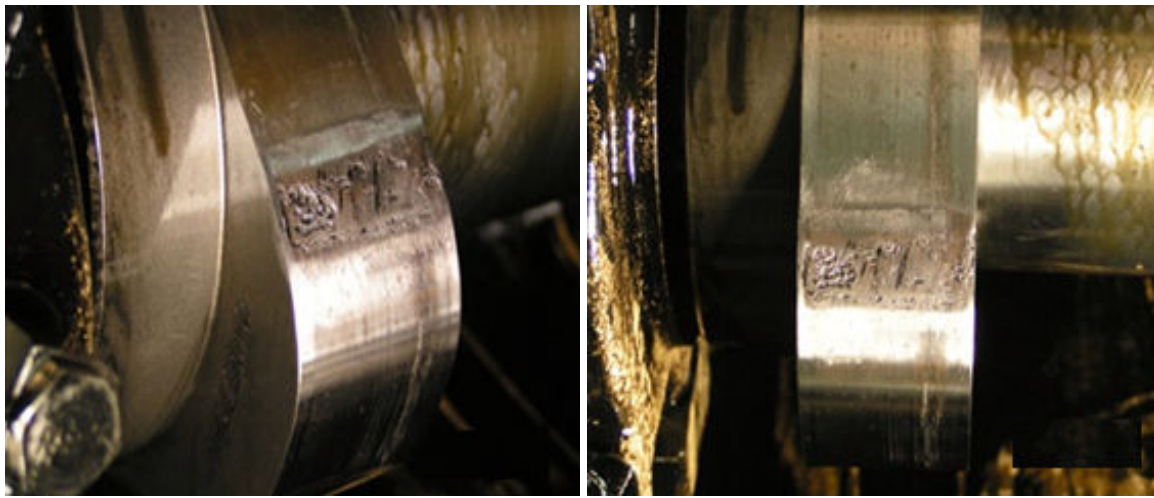
Fig. 5. Damage of a cam

In the second stage, fatigue cracks get bigger and spread to larger parts of the material. Oil plays a pronounced negative part in the process of crack expansion. The oil, which is present in the contact area within the Hertzian contact stress limits is a subject of high unitary pressures and gets into existing surface crevices. **The ability of oil to penetrate them is higher when its viscosity and surface tension are lower. Thus, highly processed oils, containing dispersing additives and detergents are more penetrable** and such oils are used in the lubricating systems of ship engines. Oil as a non-compressible liquid is pumped under high pressure into a crack (at pressure-circulation lubrication) and it acts as a wedge and enlarges the crack. Improvement additives of high physical and chemical adsorption properties, get adsorbed on the crack surfaces and lower the surface energy and decrease the continuity of material inside the crack that was due to adhesion. Thus, oils with surface active additives are characterized by strong wedge-like activity and because of this play a part in crack spreading [3].

When a roller is rolling on a cam, “surface areas” of both elements are alternately compressed or stretched. The stretched particles, strongly connected to the base, tear some parts of the material, which as a result of fatigue cracking lost or diminished its cohesion with its own specimen.

Analysing the problems connected with wear of elements on the discussed unit and also on twin ships, a conclusion can be drawn that calculations and construction of the whole gear system should be checked again.

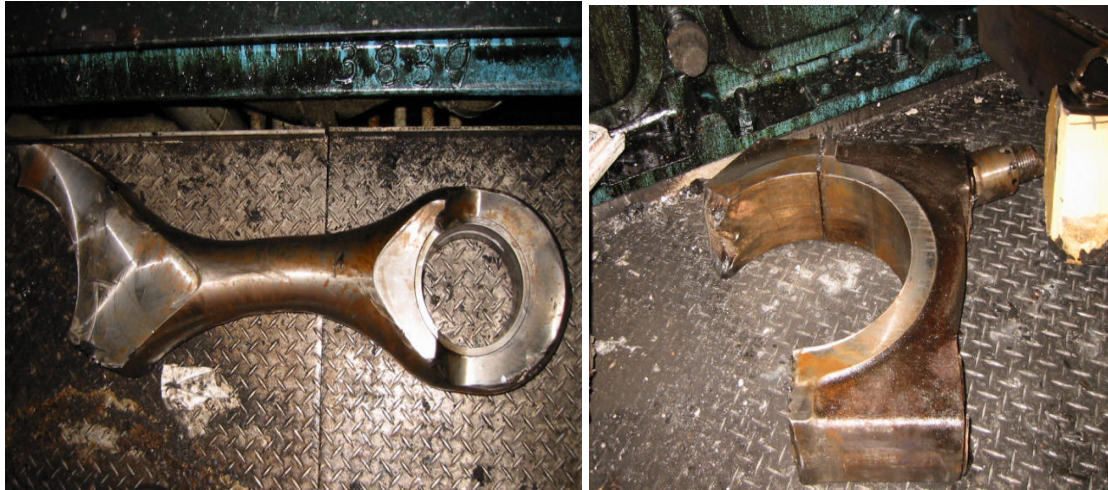
During seismic measurements of oil resources, a burst of a cylinder block of one of the engines took place. One of the engine systems got almost completely torn apart. It also became the cause of fire in the engine room. Additionally, the so-called secondary damages appeared – not only the elements of the engine but also other machines in the engine room suffered. The base of the connecting-rod got completely severed. (Fig. 6).

Fig 6. The photographs show the severed connecting-rod bases of the Bergen- Diesel engines on one of the “Seismic Research” type ships.

An analysis of the condition of particular elements was carried out in order to find the source and cause of the damage. It was noticed, among others, that the nut of the connecting-rod bolt at the time of the damage was not in its proper position. Attention was focused on the appropriate tightening of the connecting-rod bolts [4]. The area where the nut contacts the connecting-rod showed pronounced deformations, which rather did not appear at the time of the failure. After a complete analysis the following conclusions were reached:

- the main cause of the failure was the insufficient (at the proper time) tightening of the nut of the connecting-rod bolt,.

- insufficient initial tightening of the nut caused its further loosening and gradual shearing of the securing nut;
- when the nut was completely loose, additional shearing and stretching forces were acting on the bolt at engine operation, and at the same time the lubricating oil valve was getting opened or closed depending on which direction the piston (TDC-BDC “*Top Dead Centre – Bottom Dead Centre*”) was moving;
- the above were the main reasons of disappearance of the lubricating oil in the cylinder barrel and of the cooling oil at the piston head;
- because of lack of lubrication and piston head cooling, the piston got stuck in its barrel and as a result the whole connecting-rod base was severed, the piston pin cracked and the engine cylinder block burst;
- until the moment when the engine was fully stopped, the spinning crankshaft “threw” parts of the connecting-rod outside.
