ANALYSIS OF DAMAGE OF SELECTED ELEMENTS OF THE INJECTION SYSTEM OF MARINE DIESEL ENGINES

Artur Bejger

Abstract

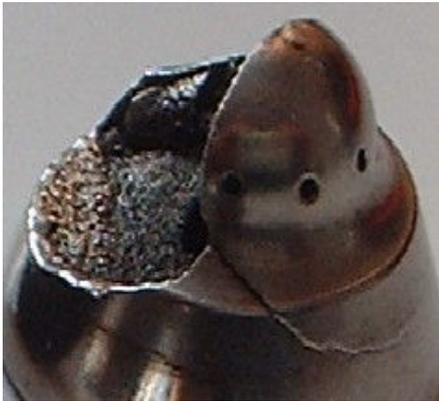
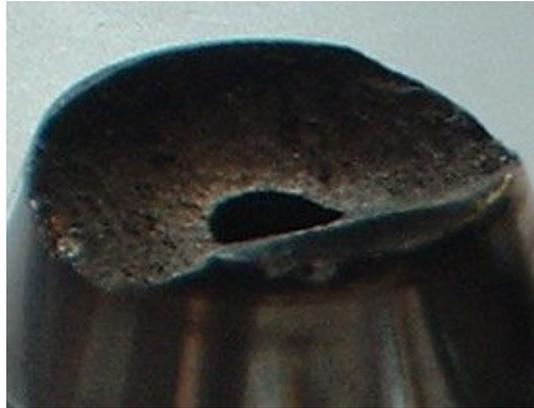
During the studies carried out by the author of this paper, faulty operation of brand new atomizers occurred (after the ship owner had changed its spare part supplier) which was caused by a badly made atomizer well. It can consequently lead to a change of pressure under the needle and damage the atomizer itself (Fig.1).

Fig. 1. Partial (fig. a) and total (fig. b) breakaway of the atomizer nipple

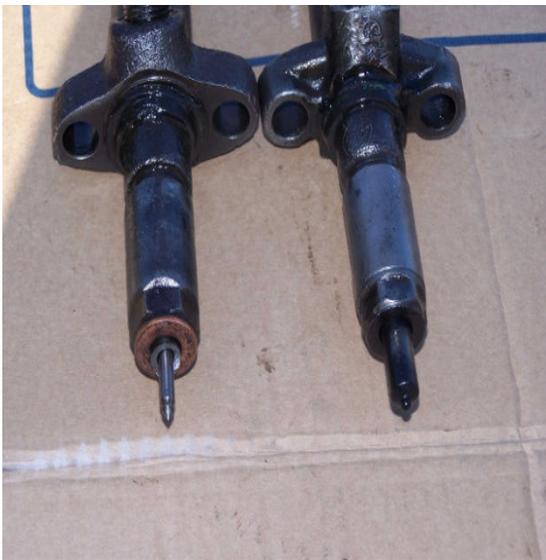
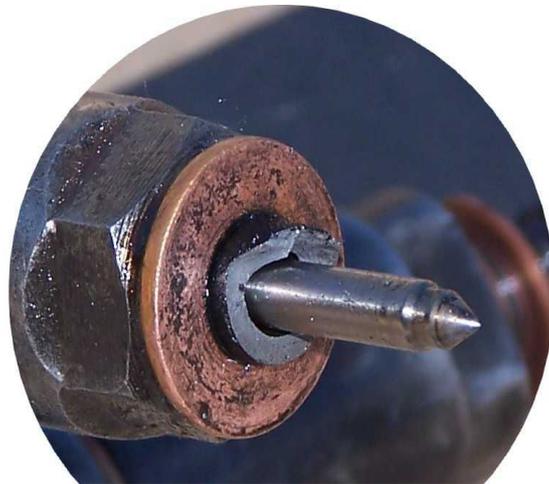
Another example of atomizer damage, very dangerous to the engine, which the author of this paper encountered, is breakaway of a whole part of the atomizer body – the needle guide (Fig. 2). It is an example of using very bad quality fuel.

Fig. 2. An example of damage (breakaway) of a part of the atomizer body caused by the improper quality of fuel

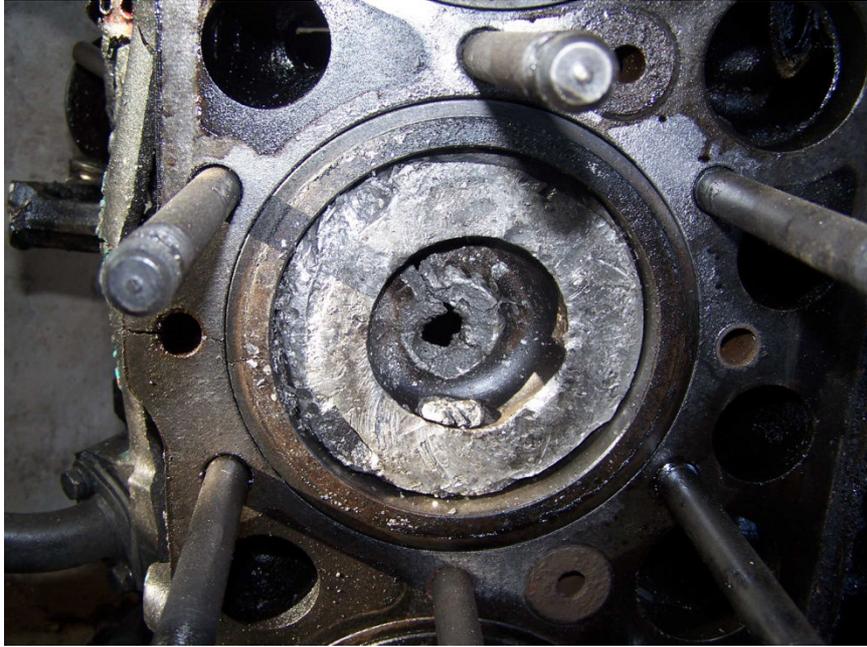
Change of thermal conditions of atomizer operation, caused damage in the structure of the atomizer body material and as a result its cracking. At first the effect of this failure is usually damage of piston crown (Fig. 3), and later the damage of the whole piston – rod - crank system together with the engine body. Using improper quality of fuel (with too high viscosity) together with the wear of the seat - atomizer needle cone system causing a change of pressure under the needle lead to a failure of an atomizer of one of the engines manufactured by Caterpillar (Fig. 4)

Fig. 3. Damage of the piston and engine body being the result of the breakaway of the lower part of the atomizer body (from Fig. 2)

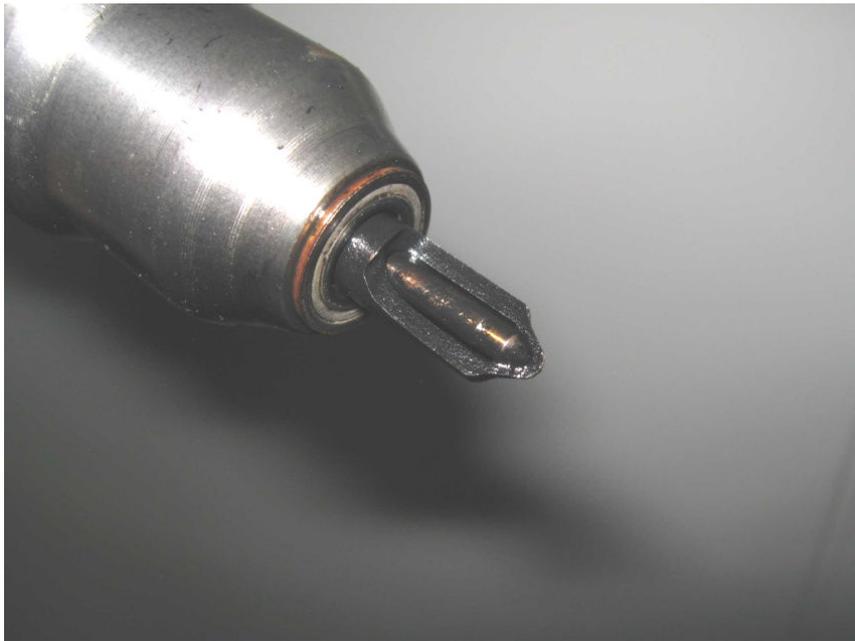
Fig. 4. A view of the damaged atomizer in a an injector pump of the Caterpillar engine

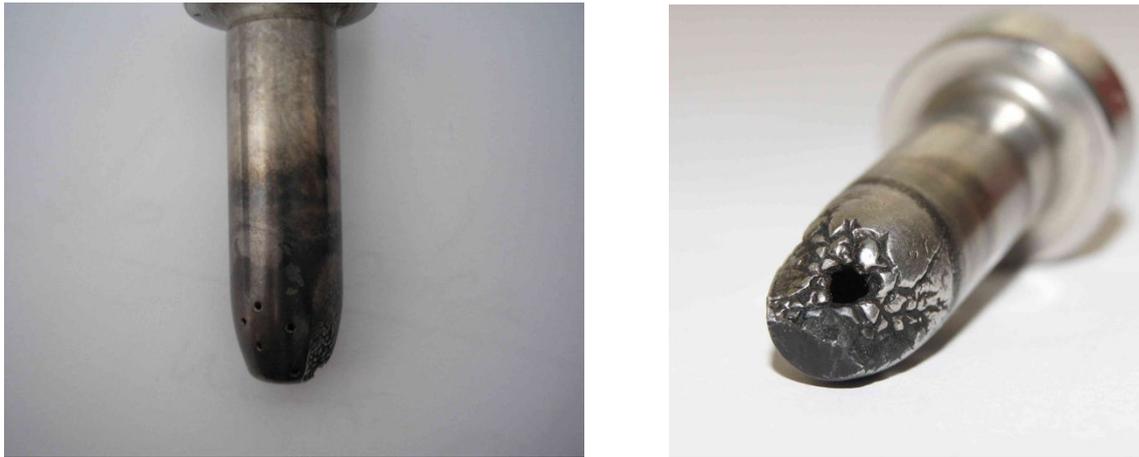
Interesting wear which the author had a chance to consider was the damage of directional multi-hole fuel atomizers of the Sulzer RTA 58 engine. After a relatively short period of injector operation, atomizers of one of the systems suffered from wear visible in Fig. 6. The ship owner decided to replace the atomizer with new ones, made by renowned manufacturers, which did not, however, bring expected results.

Fig. 6. Erosion-cavity formation damage together with local overheating (scorching) of the atomizer in a Sulzer RTA 58 engine

Analysing the kind of wear and the engine operation and maintenance manual the author of this paper came to a conclusion that when fuel flows from the injector, gas turbulence appears in the combustion chamber causing erosion- cavity wear on the opposite site of the holes. Also, local overheating of the atomizer takes place. The cause of this lies in the too pronounced wear of a part of the head (fig. 7). In practice a similar effect could occur due to the crew error in the case of a too deep milling of the injector seat in the head during cleaning. It causes deeper seating of the injector and its more pronounced protruding form the combustion chamber. It is the main cause of turbulence appearance which is responsible for the cavity erosion on the surface of the atomizer.

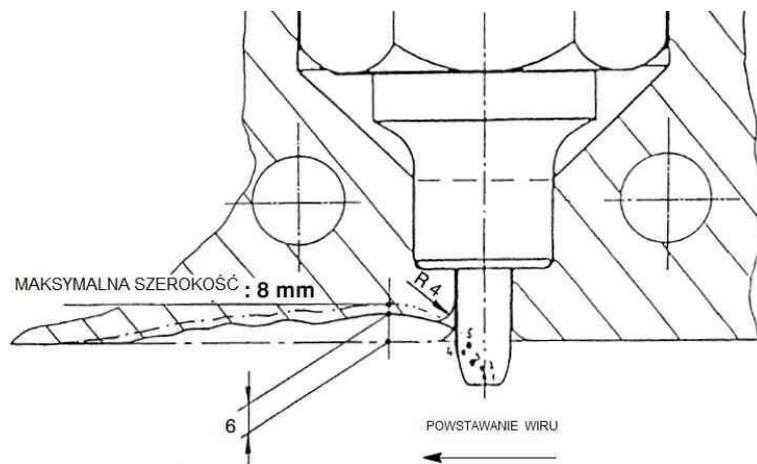
Fig. 7. A view showing the wear (scorching) of the inside part of the head of the Sultzer RTA 58 engine which causes the "cavity turbulence" and atomizer damage as shown in Fig. 6

In the Sulzer RTA engines, very close to the lower part of the head (from the combustion chamber side) there is also a cooling duct. A decreased distance (because of the needle material scorching) between the cooling area and the combustion chamber causes much lower heat reception also from the atomizer tip itself.. In the studied case two phenomena interfered and they both lead to the studied kind of wear; cavity erosion and local overheating.

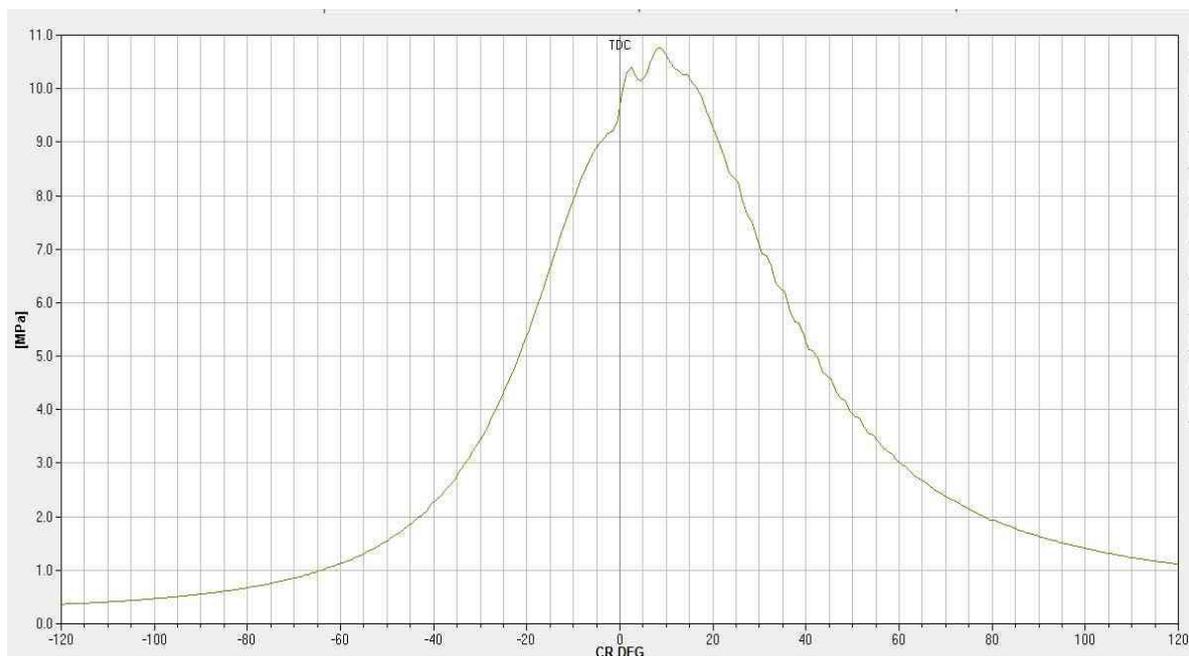
In the case of new atomizers, the quality of fuel jet mainly depends on compression pressure (counter pressure in the combustion chamber) and the pressure under the needle in the injector. In one of the engines (Wartsila SW 280) a problem of incorrect combustion with high emissions of smoke occurred. For the crew the problem was so important that earlier they had replaced precision pairs of injection pumps with new ones, also they replaced atomizers together with the spring and they checked the supercharging pressure and all other parameters which could lead to increased emission of smoke. After preparing a developed indicator graph, it was observed that the maximum pressure had a “dual character” – there was an increase, a decrease and then another increase of pressure, this time main in character, until its maximum value was reached (Fig. 8) It is the case when an incorrectly sprayed fuel jet reached the hot surface of the cylinder barrel, initial fuel combustion took place, after which the main combustion process occurred. As it was mentioned before this effect is influenced by compression pressure and by the fuel pressure under the needle (with faultless atomizer holes). Accordingly, it was suggested that if the compression pressure was correct, just as other parameters, then probably “smoke emission” and “dual effect of the maximum pressure of the combustion process” could probably be ascribed to a faultily manufactured injector well. In fact, it turned out that the company supplying atomizers had changed its sub-supplier and thus a batch of **new** atomizers delivered onto the ship was faulty. The problem of brand new faultily manufactured parts is unfortunately becoming more frequent.

Fig. 8. A developed graph of an injection process run for a faultily manufactured atomizer well which changes the quality of fuel jet (description in the text).

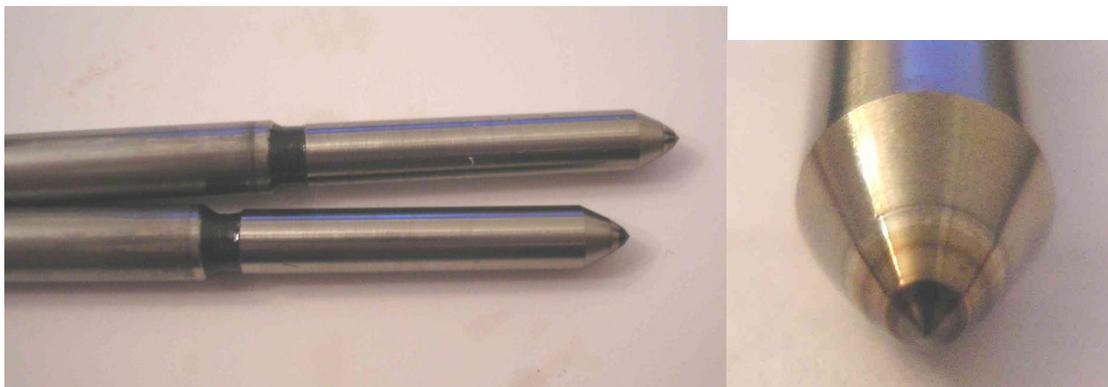
Engine smoke emission caused by the change of fuel jet was observed when performing diagnostic measurements of a marine diesel engine of the MAN D2848 type. This engine belongs to the group of the so-called “difficult to diagnose” engines. It operates in the fork-like system of cylinders and it does not have indicator taps. The problem was due to the change of pressure under the needle caused by scorching of the atomizer needle cone (Fig. 9). It was important that the scorching took place during the guarantee period (just after a short period of operation time). Again it was caused by bad quality of atomizer parts.

Figure 9 Scorched atomizer needle cones.

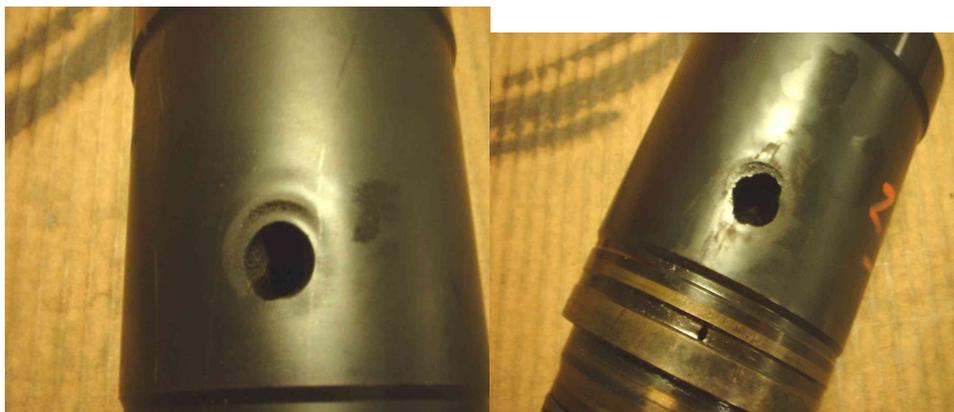
Typical wear of injection pump leads to erosion and cavity formation action of fuel on the overflow hole of the pump (Fig. 10).

Figure10 Erosion - cavity formation of overflow hole of the injection pump cylinder

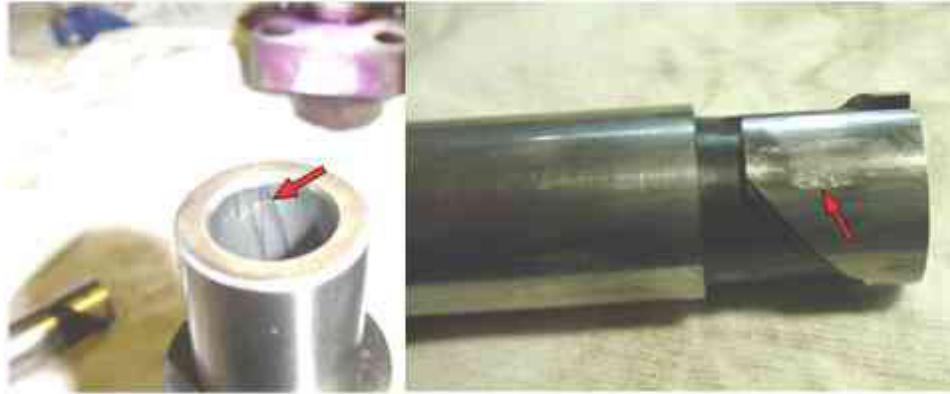
At the moment the failures caused by low quality spare parts are more common. Figure 11 shows seizing of a precision pair of an injection pump after about only four hours of operation.

Fig. 11. Seizing of a precision pair of a (new) injection pump after four hours of operation due to very low quality of manufacturing of parts (Chinese manufacturer)
