## FACTORS DETERMINING HOISTING SHAFT ROPE DURABILITY

### **Abstract**

*The paper deals with factors determining the run and intensity of the wear-out process of mining hoist mechanisms. On the basis of the carried out experimental tests of a balance rope being a part of such a mechanism it was proven that conditions of the rope operation have a great influence on the kind and effects of its wear-out process. It was found that the basic cause of the rope strength features degradation is electrochemical corrosion and particularly – a chemical variant of this process. Of course, tribological wear is observed too.*

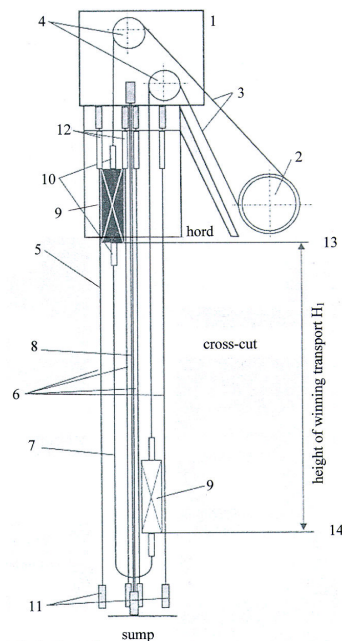
Fig. 1. Structural scheme of a shaft hoist: 1 – hoist tower, 2 – hoist wheels, 3 – lifting ropes, 4 – steering wheels, 5 – shaft, 6 – guide ropes, 7 – balance rope, 8 – fender rope, 9 – hoisting vessels, 10 – suspension gears, 11 – guide ropes weights, 12 – emergency breaks device, 13 – upper loading level, 14 – lower loading level

In presented paper, tests of balance ropes of a mining hoist, shown in Fig. 1, have been discussed. The main practical aim of conducted research was to confirm the rightness of the decision concerning an exchange of a used rope for a new one, whereas the cognitive goal was to determine the causes of its accelerated wear-out. Achievement of both goals will be of great practical importance as the tests results will make up a database useful for making similar decisions in the future; besides, they may provide information for users how such mechanisms should be operated.

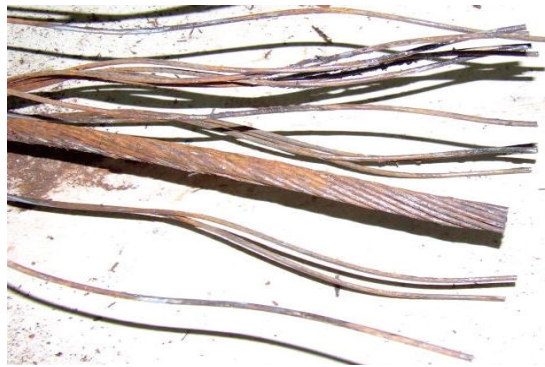
As the result of a carried out inspection, there was found a deep corrosion of the external layer wires spreading onto the inner layer wires, especially on the return sections – when the hoist cabins were at the level of 850m. below the vessels. Traces of the corrosion related wear-out process are shown in Fig. 2, where a fragment of a partly unlaidd rope has been presented.

*Fig. 2. Some fragment of the rope before the tests with visible corrosion*

After being dismantled, the rope was found to have local losses and losses in soldering, though on not more than three wires of the external and internal layers, at the length equal to the rope seven diameters (~270mm.). Material losses in the wires due to friction and dents at the place of the layers contact, were not found.

After being cleaned, the broken wire of the external layer had a diameter about 2,0 mm. which means a decrease in the wire diameter by 13% compared to new wires and respectively, 24,4% decrease in their cross-sections. However, a visual examination revealed that the discovered loss was not caused by a friction wear-out but rather by corrosion whose effects were partly removed by cleaning.

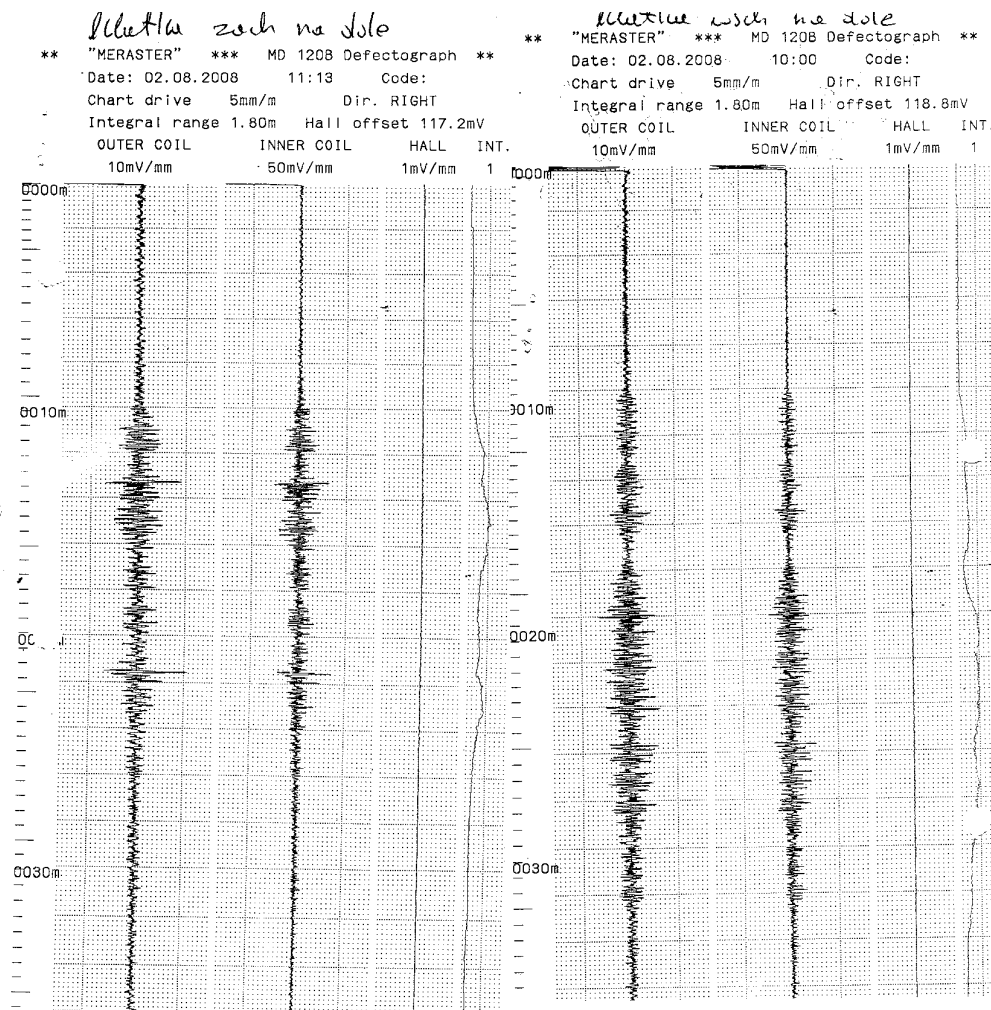
A fragment of the test result records has been presented in Fig.3. The record concerns the rope sections in the places of its returns (from 10 to 30 meters) under both cabins.

Fig. 3. Records of results of ropes magnetic tests in the place of the rope biggest weakening (the test parameters in the head of the record)

On the ground of the calculations using the indications of the internal coil integrator [3,10] it was found that losses of the metallic section (sum of cross-sections of particular wires) range from 15,1 to 29,5%, compared to a new rope. The rope changes (losses in the cross-section), found on the basis of magnetic tests, confirm the earlier observations – made during organoleptic tests.

Thus, the main goal of the research has been achieved, that is, it has been proved that the decision on the rope removal from operation was right as it lost its operational features to a degree which justified such a choice.

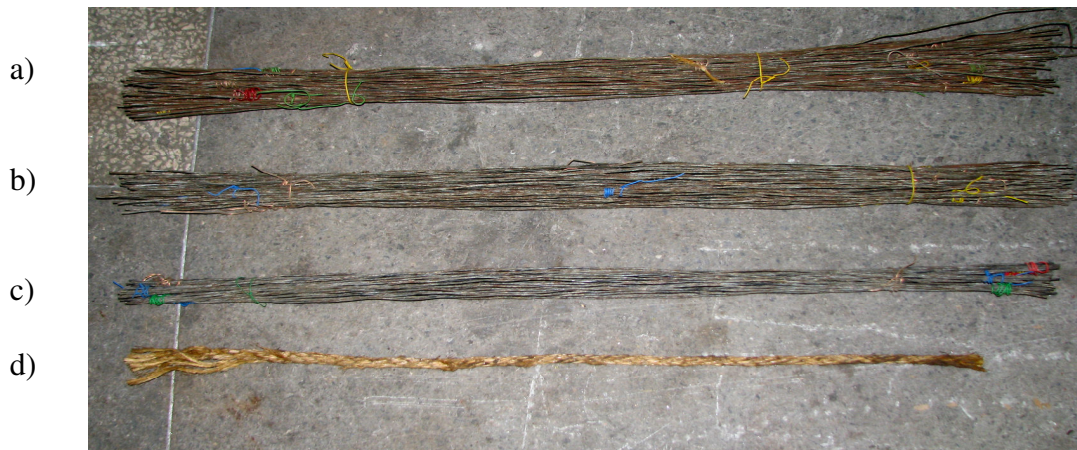
Wires of an untangled, two meter long section of the rope, coming from the return under the eastern case, were tested. The tests covered 100% of the wires which had been straightened, cleaned from the lubrication and partially, mechanically- from corrosion products – Fig.4.

Fig.4. Prepared for tests segments of wires of the rope layers: a) external, b) central, c) internal and d) core

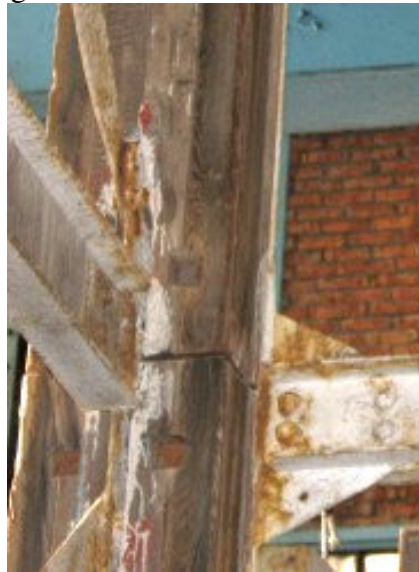
Corrosivity of operating environment for mining mechanisms can be well reflected not only by rope but also by traces of corrosion on the hoist structure – see Fig.5. Thus, it can be said with high probability that one of the causes of the rope weakening is the influence of the environment factors. This can be proved by the fact that the external layer of the rope was more damaged than

the other ones which results from its being more exposed to the environment components which appear in the form of moisture and gases.

*Fig.5. Fragment of the shaft bearing structure with visible traces of corrosion*

Analyzing forms and effects of the environment factors, it can be said that the products of corrosion observed on the surface of the rope and its particular wires are the effect of mainly electrochemical corrosion. Accounting for the operation conditions of the rope mechanisms it can also be stated that corrosion products occurred in result of formation of many oxygen micro-cells which appeared in places where water particles settled on the rope.
