## TYPES OF DAMAGES TO TURBINES OF AIRCRAFT TURBINE ENGINES; DIAGNOSING CAPABILITIES

Artur Kulaszka, Marek Chalimoniuk, Józef Blachnio

*Air Force Institute of Technology*  
ul. Księcia Bolesława 6, 01-494 Warszawa 46, Polska  
tel.: +48 22 6852282, e-mail: artur.kulaszka@itwl.pl

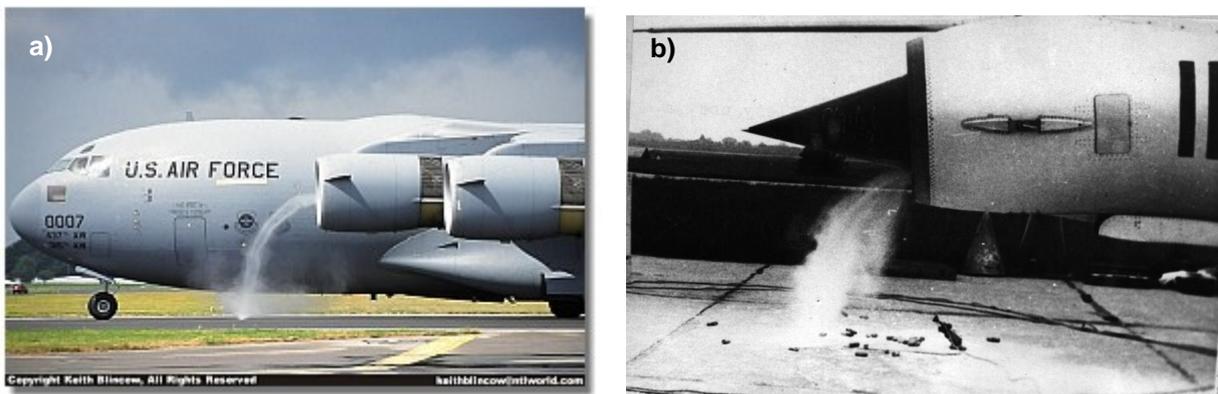
The structure and the principle of operation of a turbine jet engine is closely related with the high-intensity air flux flowing through its gas path – the intake, compressor, combustion chamber, turbine, exhaust nozzle. The air taken through the intake is not always free from impurities, which penetrate into the engine. This depends on the location of the engine in the airframe (Fig. 1), condition of airfield pavement (Fig. 2), errors made while operating the aircraft.

Fig. 1. Types of vortex at engine intakes [6][7]

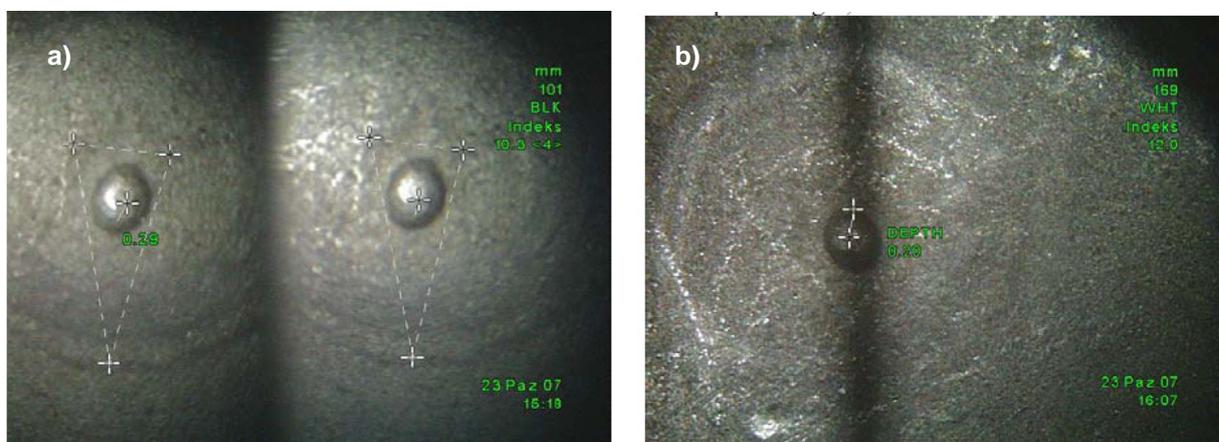
In [4] presented are methods of measurements of surface defects, which are based on digital recording of the videoscope image with the "Stereo" method ("Stereo Probe") and with the "Shadow" method ("Shadow Probe") - Fig. 9.

Fig. 9. Measurement of convexity radius with methods [4]: a) „Shadow”, b) „Stereo”
